Customer: Fort Mill Ornamental

Project: 100276 / CLE02218

Product: ZS311N107, Z series, Super Durable

Evaluation: 7.8.2 Salt Spray Resistance

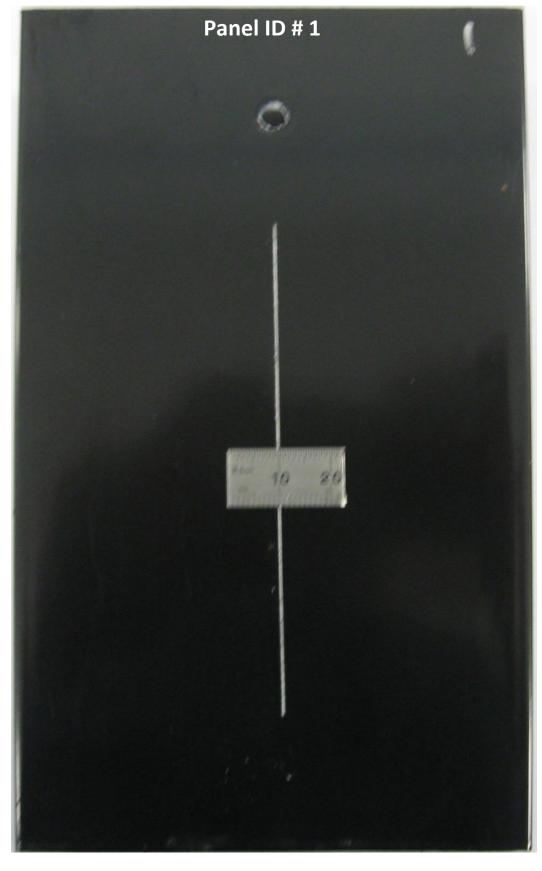
Panel ID	Creepage Form Scribe in mm		Blistering	
Puller ID	Mean	Rating No.	Area Failed, %	Rating No.
1	0	10	No Failure	10
2	<0.5	9	>3%?	8
3	0	10	<3%	8
4	<0.5	9	<1%	9

**Conclusions:** Parts 1 and 4 both passed for scribe creepage and blistering in the test specimen field. Parts 2 and 3 both passed for scribe creepage and blistering in the test specimen field. The bottom area of Parts 2 and 3 produced a very blistered appearance. This contamination is most probably due to the observed handling of the parts prior to coating and is not representative of the pretreatment or substrate.
